Monitoring Data Record

Project Title: R-3427 (US 601 Widening) COE Action ID: 200421361 & 200421362
 Stream Name: UT Dry Branch (Site 6) DWQ Number: 3403
 City, County and other Location Information: US 601, Yadkin County (64+20-66+08)
 Date Construction Completed: Water turned 7-27-06 & Reforestation completed 3-10-06
 Monitoring Year: (5) of 5
 Ecoregion: _____ 8 digit HUC unit 03040101
 USGS Quad Name and Coordinates: _____

UT Dry Branch

Year 5 Summer – August 2011

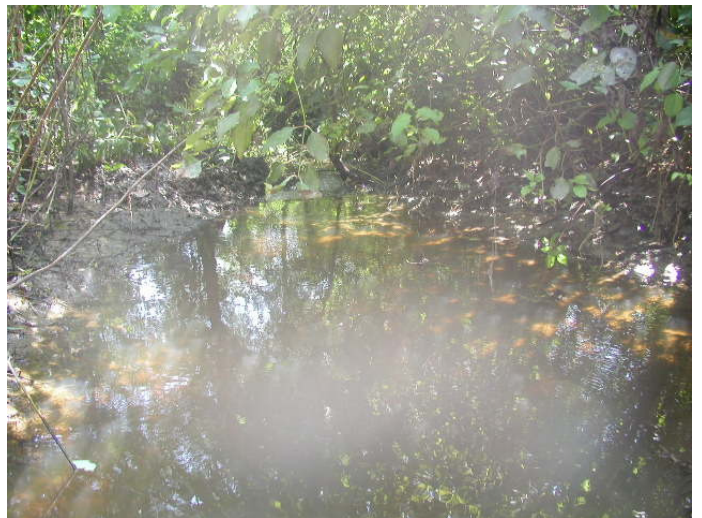
Photo Point #3 (Downstream)

Stream is highly stabilized for the Year 5 Summer evaluation. All cross vanes are functioning properly and streambanks are stabilized with woody and herbaceous vegetation. A beaver dam was noted downstream of Photo Point #3 @ STA.64+60-L- RT. NCDOT has breached the beaver dam and has contacted the USDA to remove the beaver onsite. Throughout the 5-year monitoring period NCDOT visually noted 3 bankfull events in January 2007, March 2010, and January 2011. NCDOT proposes to discontinue channel stability monitoring at this stream relocation.

Date Inspected	STA 64+60-L- RT. (PP#3 Downstream)	Station Number	Station Number	Station Number	Station Number
Structure Type					
Is water piping through or around structure?					
Head cut or down cut present?					
Bank or scour erosion present?					
Other problems noted?	Beaver Dam
